LA-UR-12-26109

Title: Opening the Plutonium-Beryllium Neutron Sealed-Source RGMA1002-468/67

Opening the Plutonium-Beryllium Neutron Sealed-Source RGMA1002- 468/67

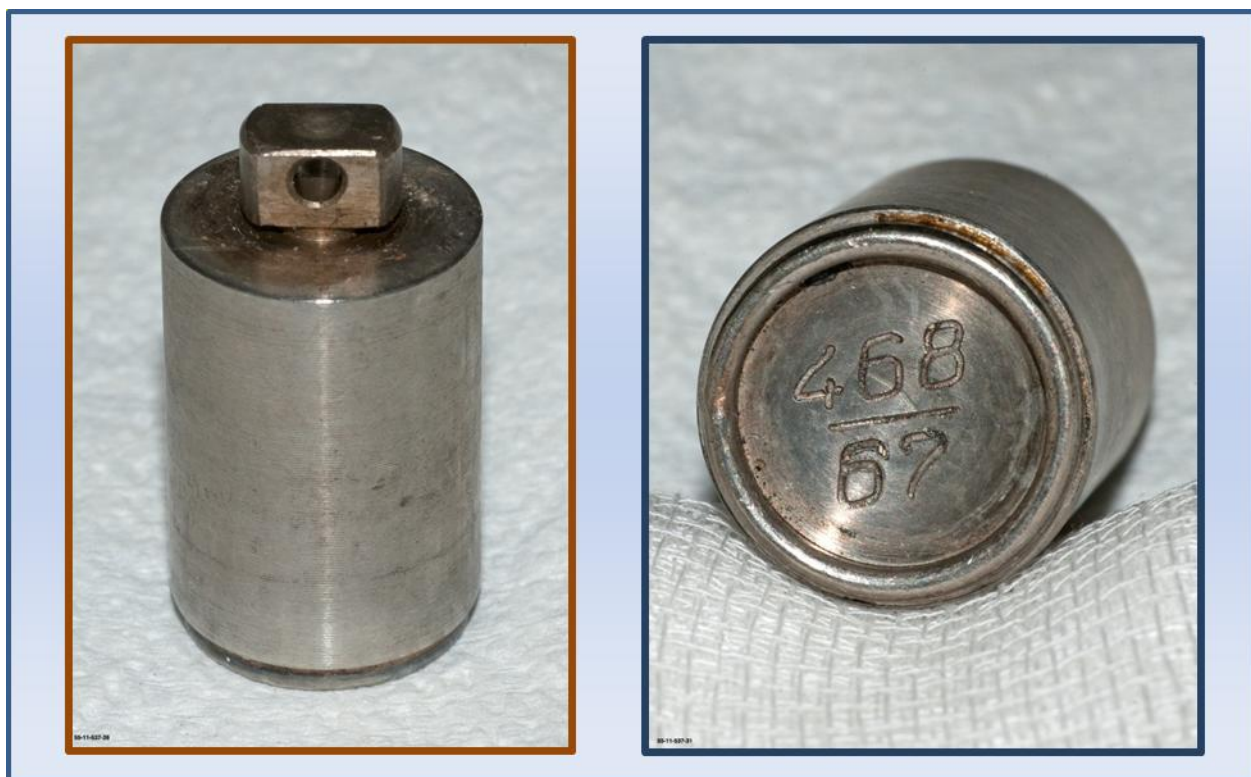
This particular sealed-source, RGMA1002-467/68, is 1.17 inches high by 0.78 inches in diameter. The cylindrical outer sealed-source container appears to be a type of stainless steel with a 0.078 inch thick plug inserted into the bottom and roll sealed in place. The bottom of the outer container was rolled under leaving a 0.085 inch high lip. The sealed-source identity was verified prior to disassembly by locating the number '468/67' scribed into the bottom of the outer container (Figure 1).

Figure 1. PuBe neutron sealed-source RGMA1002-468/67 prior to disassembly.

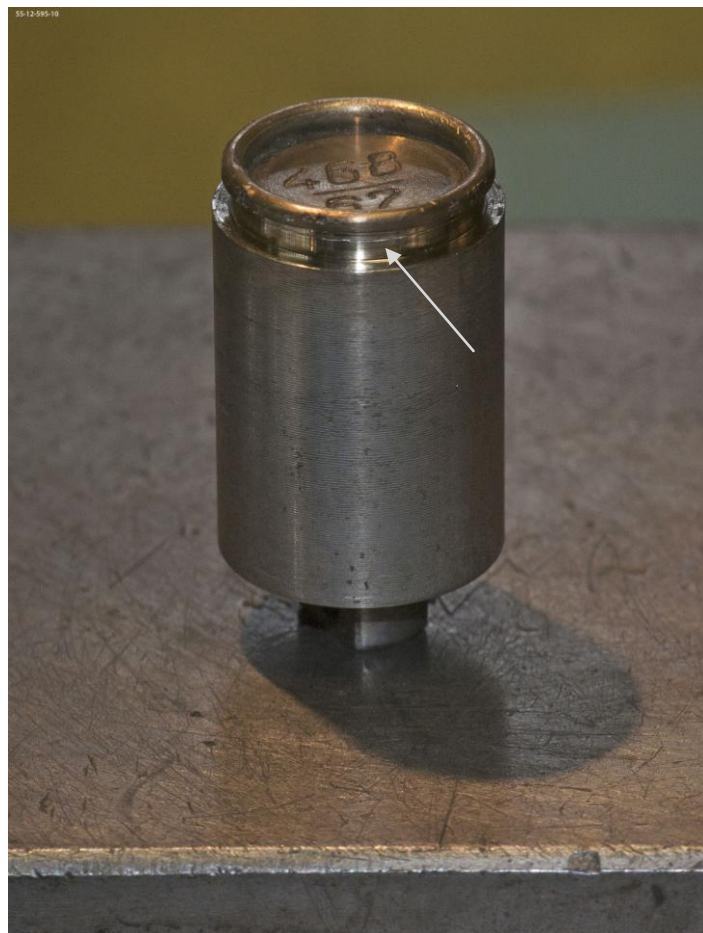
Figure 5. Separation of machined plug visible.

As planned for the first cut, the machinist set the cutting insert at 0.123 inch from the bottom of the outer sealed-source container (Z) and began cutting into the container side wall (X) (Figure 3 and 4). He slowly fed the cutting insert manually into the side wall (X) and stopped at 0.107 inch depth for photographs. A decision was made to attempt to pry off the plug after seeing a crack in the cut surface (Figure 5). Holding the container in one hand and using small needle nose vise grips to rock the plug back and forth a few times, the plug began to move. The plug slowly opened and was attached to the container on one side (Figure 6). The end of a solid inner container was evident inside of the outer container (Figure 7). The inner container slid out as the outer container was tipped horizontally (Figure 8).

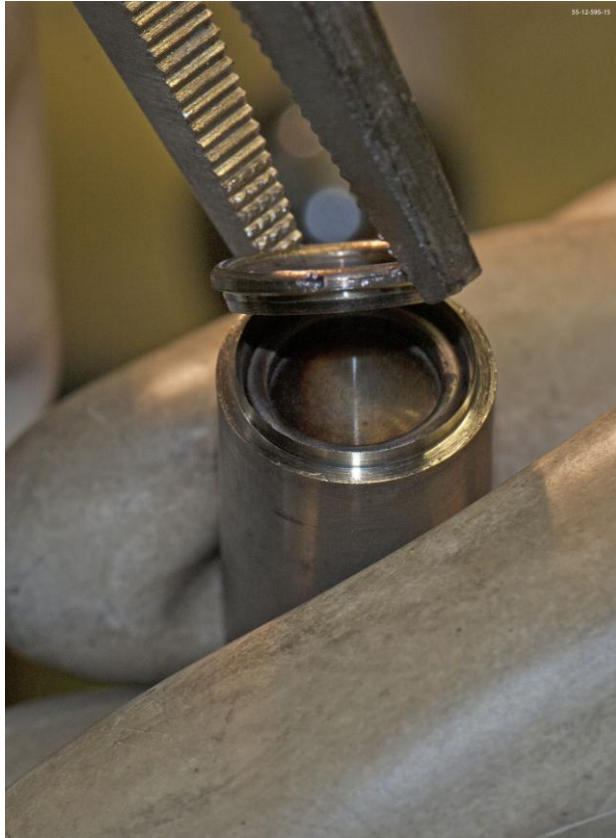
Figure 6. Removal of plug from outer container.

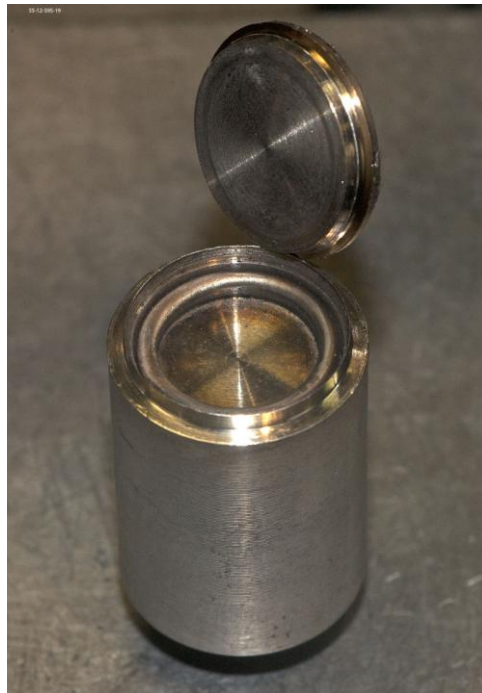
Figure 7. Plug removed from outer container, inner container visible.

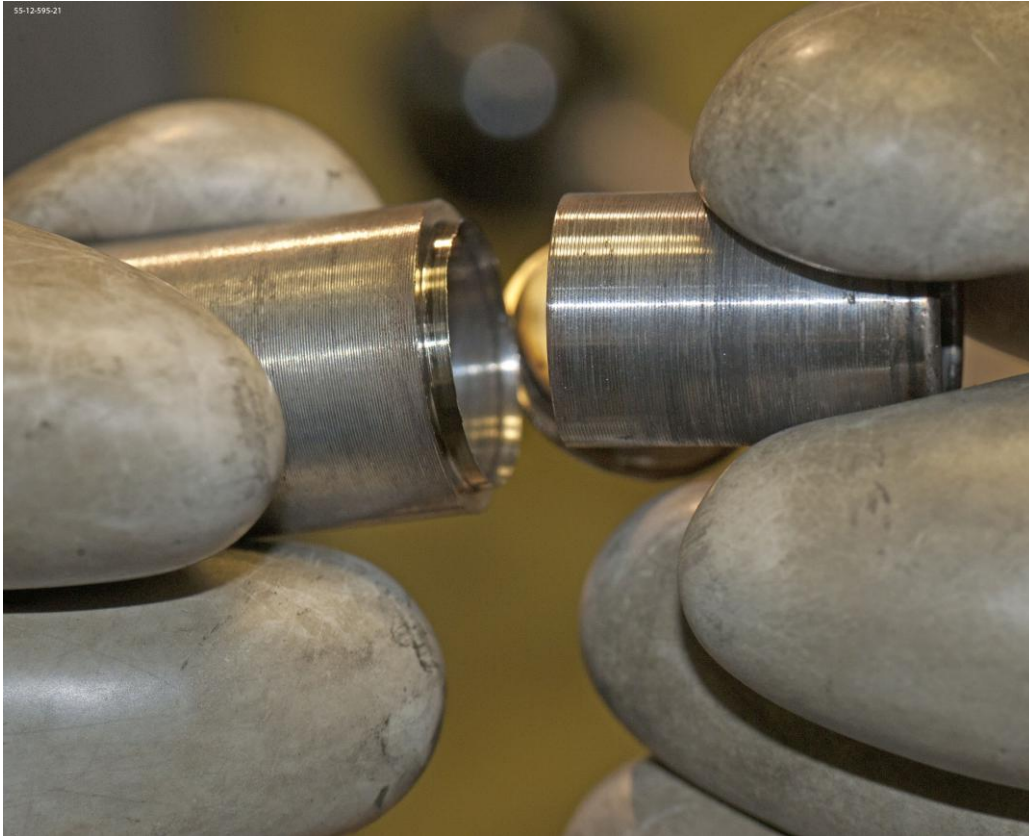
Figure 8. Removal of inner container from outer container.

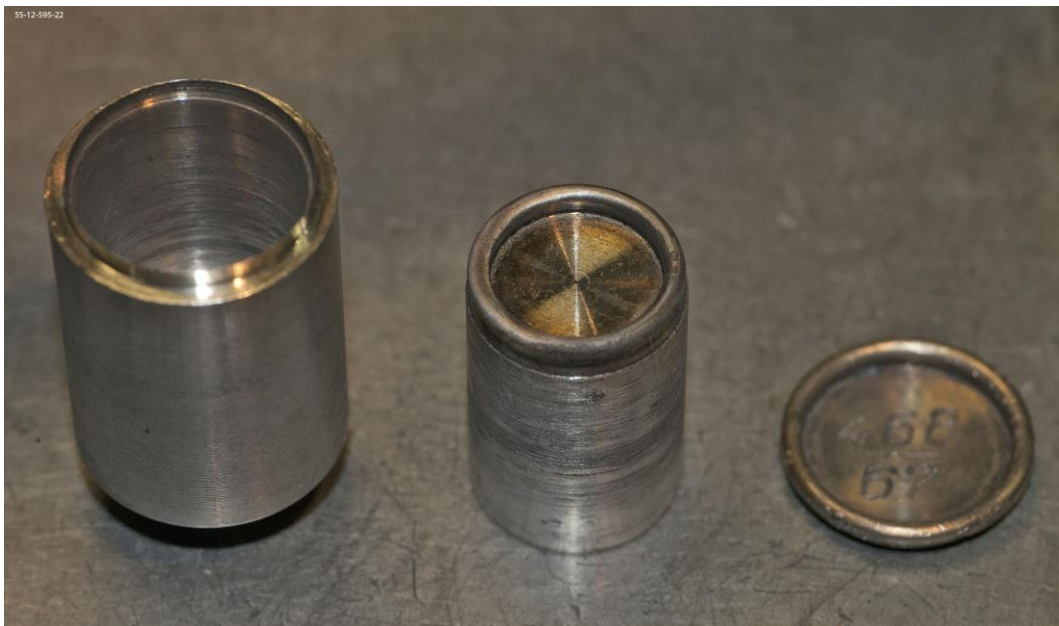
Figure 9. Outer container and inner container.

The sealed-source disassembly to this point is presented in Figure 9. The inner container was examined to determine how to open it to access the PuBe material. The bottom of the inner container was smooth and the top had a plug roll sealed in place. Due to the smaller diameter of the inner container, a 5/8 inch diameter collet was selected and installed on the lathe spindle to hold the container.

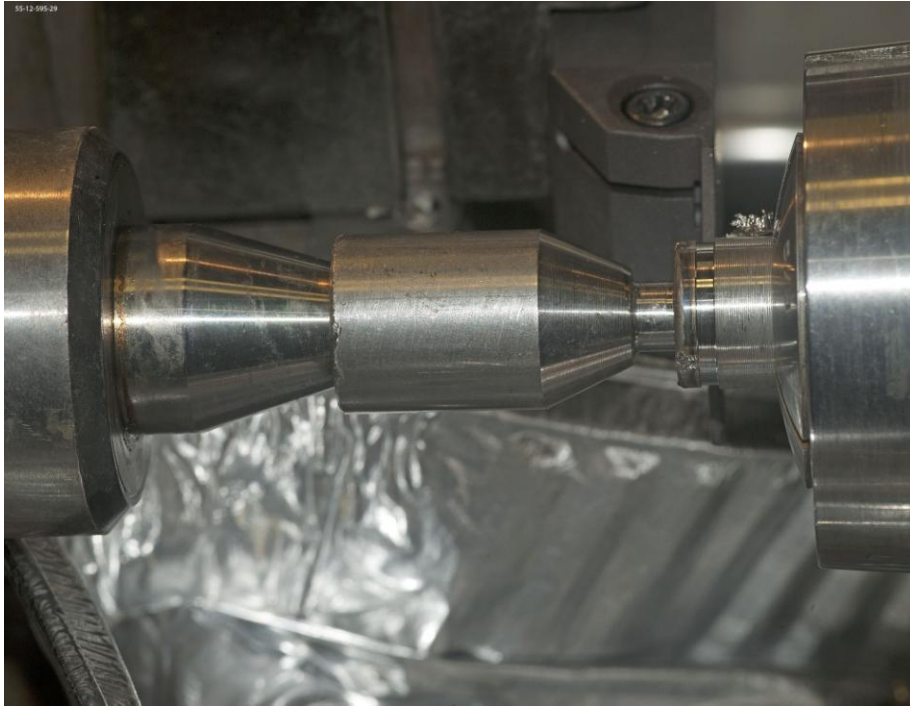
The decision was made to set the Z distance at 0.166 inch from the top of the inner container (Figure 10). Concerned that the plug might come out during machining, the tailstock was setup with a live center and pressure pad (Figure 11). The pressure pad was positioned about 0.010 inch from the plug face. Using a new cutting insert, the machinist began cutting into the side of the inner container. After feeding the cutting insert in approximately 0.040 inch (X), photographs were taken (Figure 12) and reviewed on the LCD camera monitor. Machining continued to a cut depth of 0.070 inch (X) and an attempt was made to pry the plug off with the needle nose vise grips by moving it back and forth with very little pressure while held in the collet. The plug moved indicating that the plug was loose. The inner container was removed from the collet and held vertically with one hand while using the needle nose vise grips to pry on the plug. As the plug began to move, it was noticed that the plug was attached to the container on one side. The plug was opened about 45 degrees for photographs but was not removed (Figure 13).

Figure 11. Live center with pressure pad on inner container plug face.

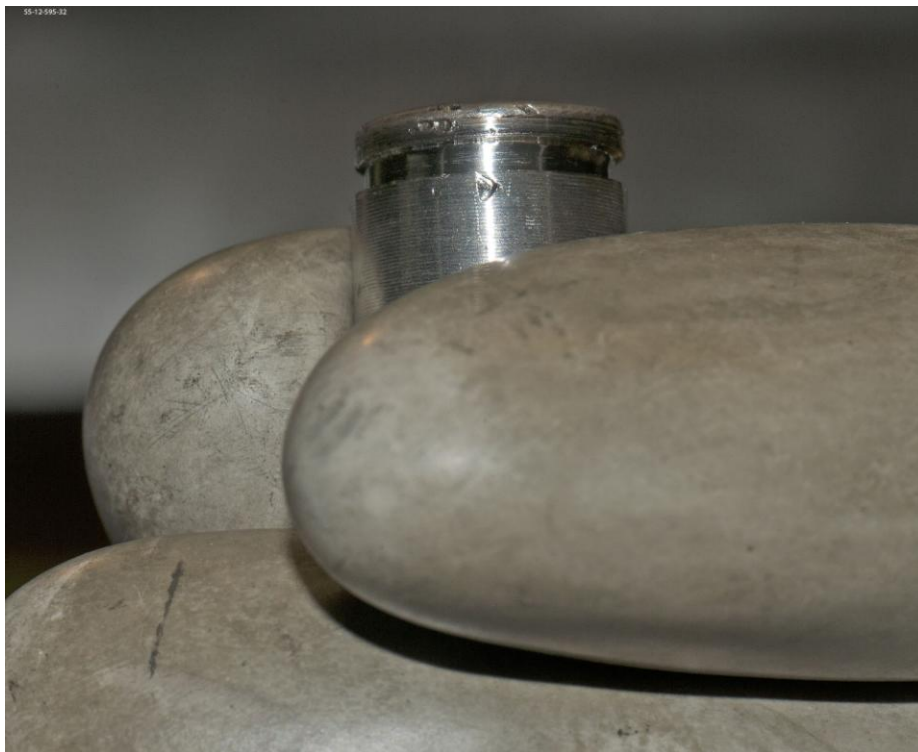
Figure 12. View of inner container and plug interface.

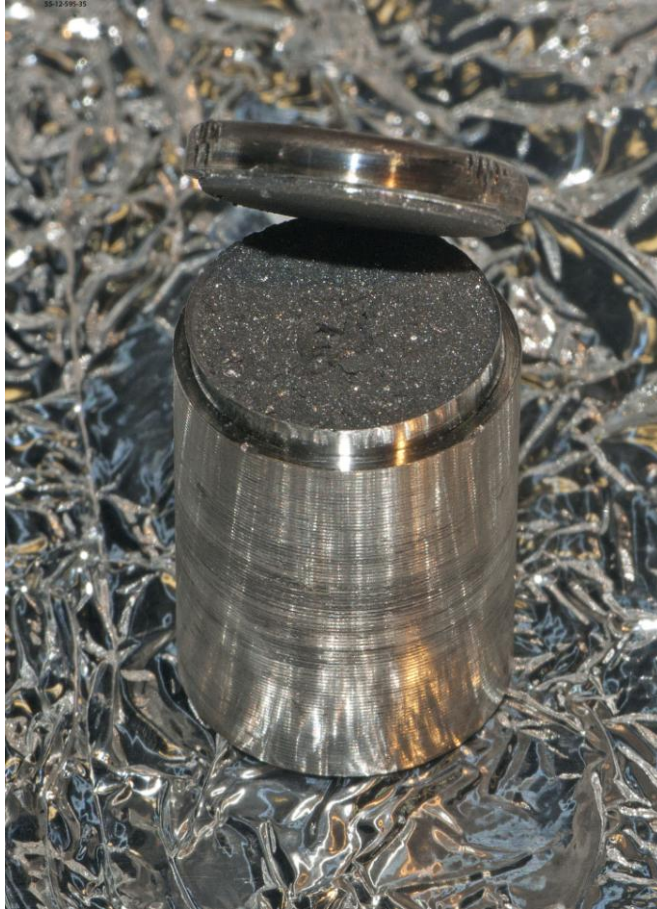
Figure 13. PuBe_{13} material visible in inner container.

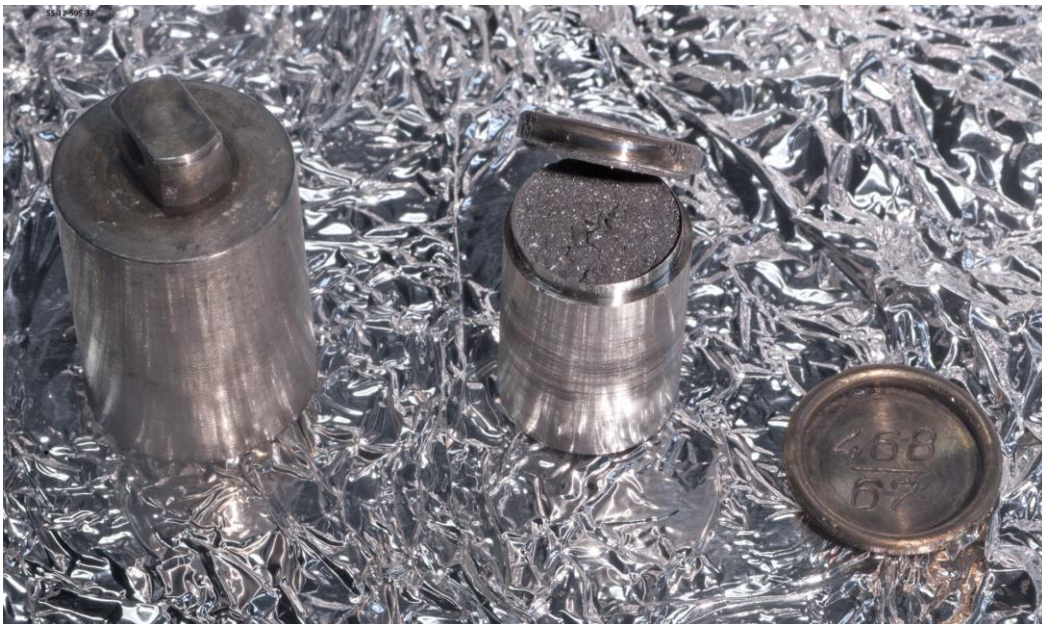
Figure 14. Disassembled neutron sealed-source.

The inner container plug was measured to be 0.48 inch diameter x 0.078 inch length and the wall thickness was approximately 0.072 inch. Figure 14 shows all pieces of the sealed-source following disassembly.
